# ADVANCED TURBINE TECHNOLOGY APPLICATIONS PROJECT (ATTAP) 1992 ANNUAL REPORT

Engineering Staff of  
Garrett Auxiliary Power Division  
A Unit of AlliedSignal Aerospace Company

March 1993

Prepared for  
NATIONAL AERONAUTICS AND SPACE  
ADMINISTRATION  
Lewis Research Center  
Cleveland, Ohio 44135  
Under Contract DEN3-335

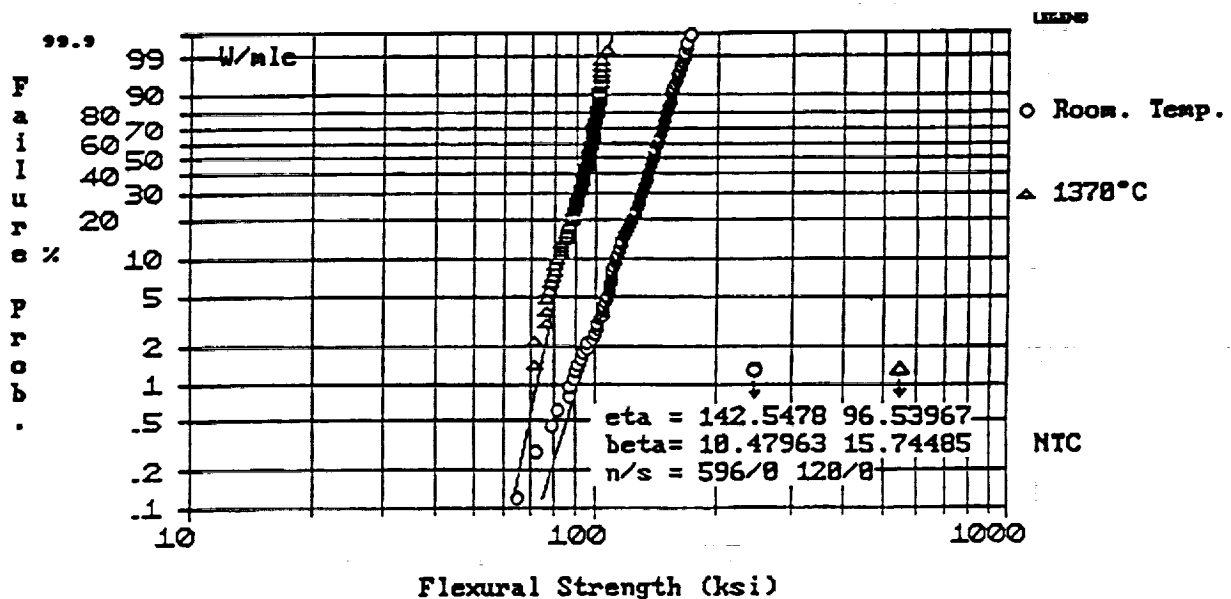
Figure 56. Aqueous-Milled, Agglomerated NT154 Weibull Distribution For Room Temperature And 1370C MOR.

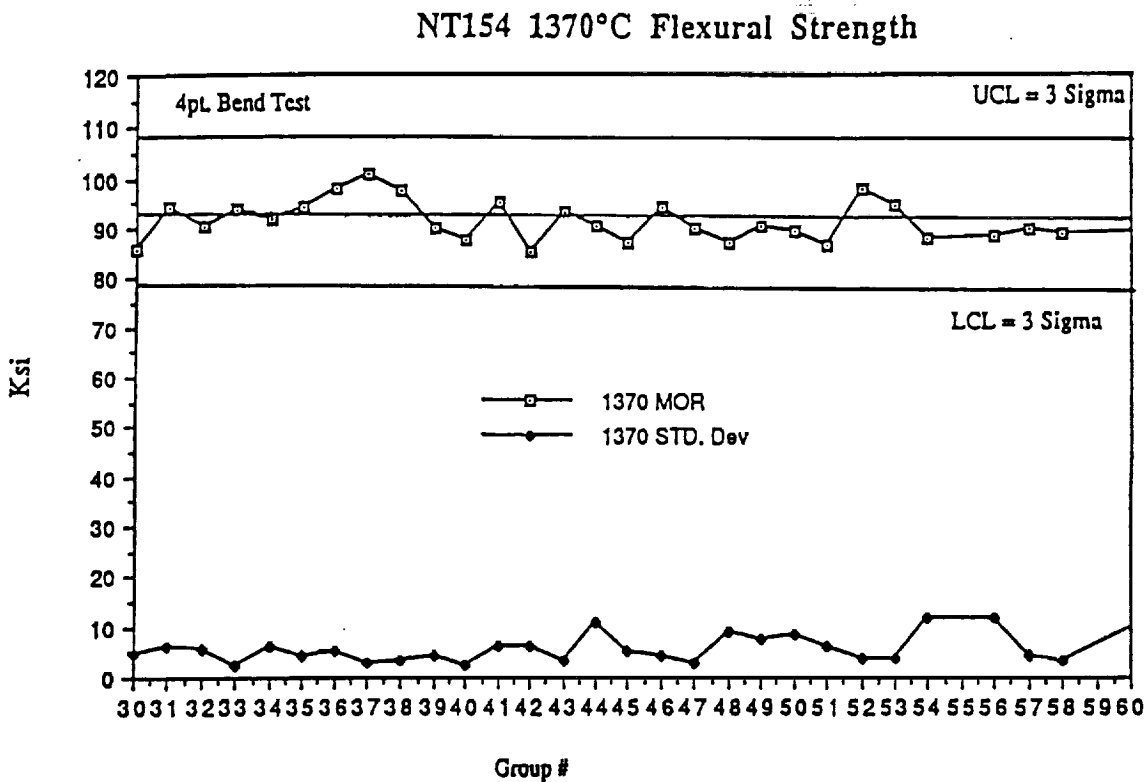
Figure 57. 1370C MOR Statistical Process Control Chart For Aqueous-Milled, Agglomerated NT154 Slip Batches 30 Through 58.

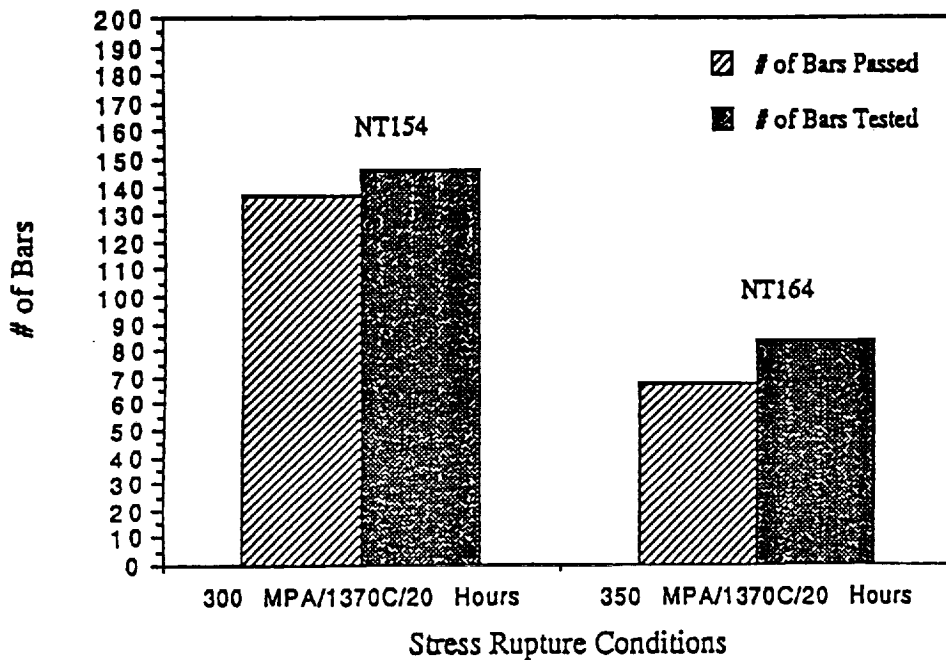
Figure 58. Aqueous-Milled NT154 And NT164 Stress Rupture Characteristics.

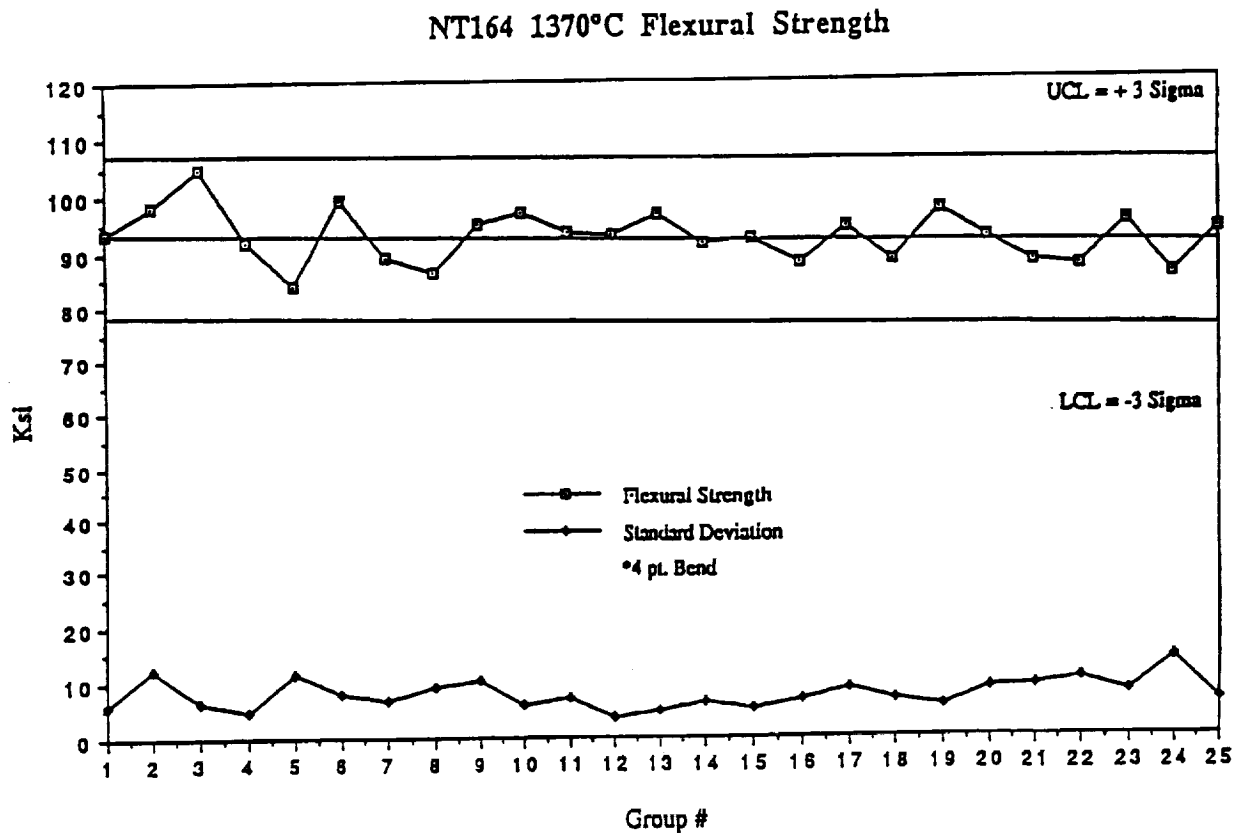
Figure 60. 1370C MOR Statistical Process Control Chart For Aqueous-Milled, Agglomerated NT164 Slip Batches 1 Through 25.

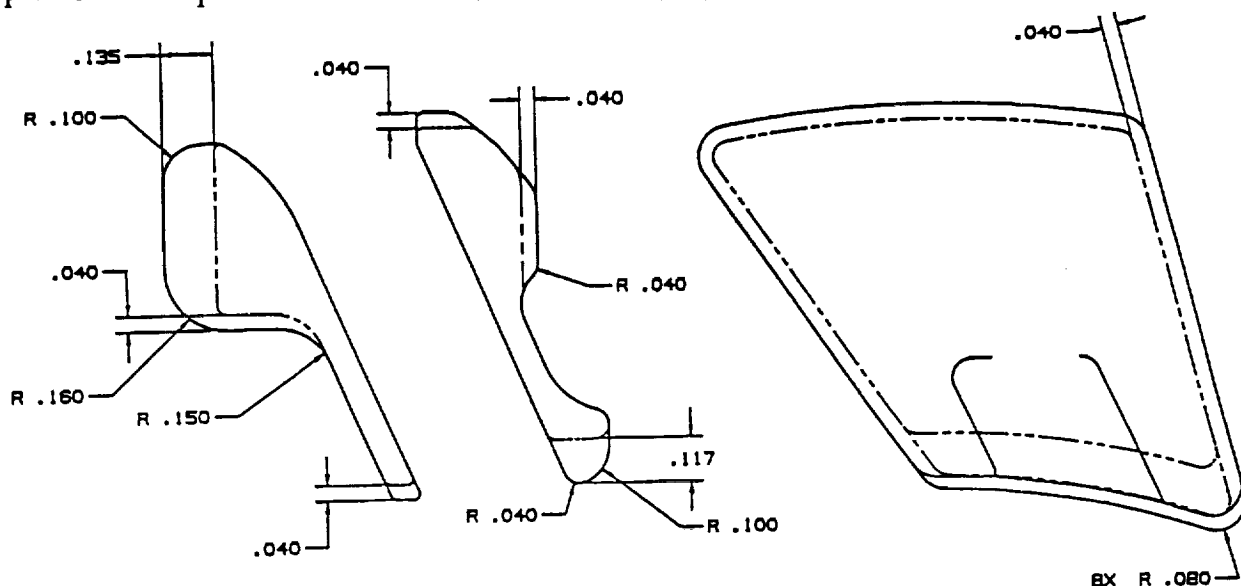
**Figure 61. Second-Generation AGT101 Stator Casting Pattern Design.**

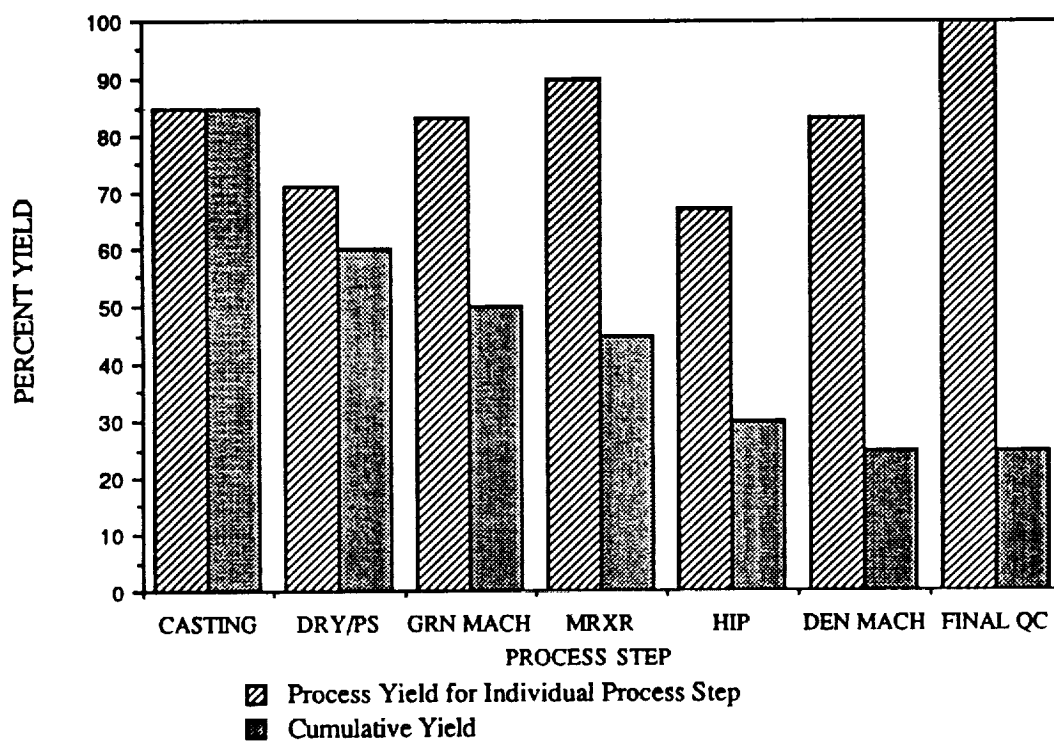
Figure 63. AGT101 Rotor Deliverable Set No. 1 Process Yields.

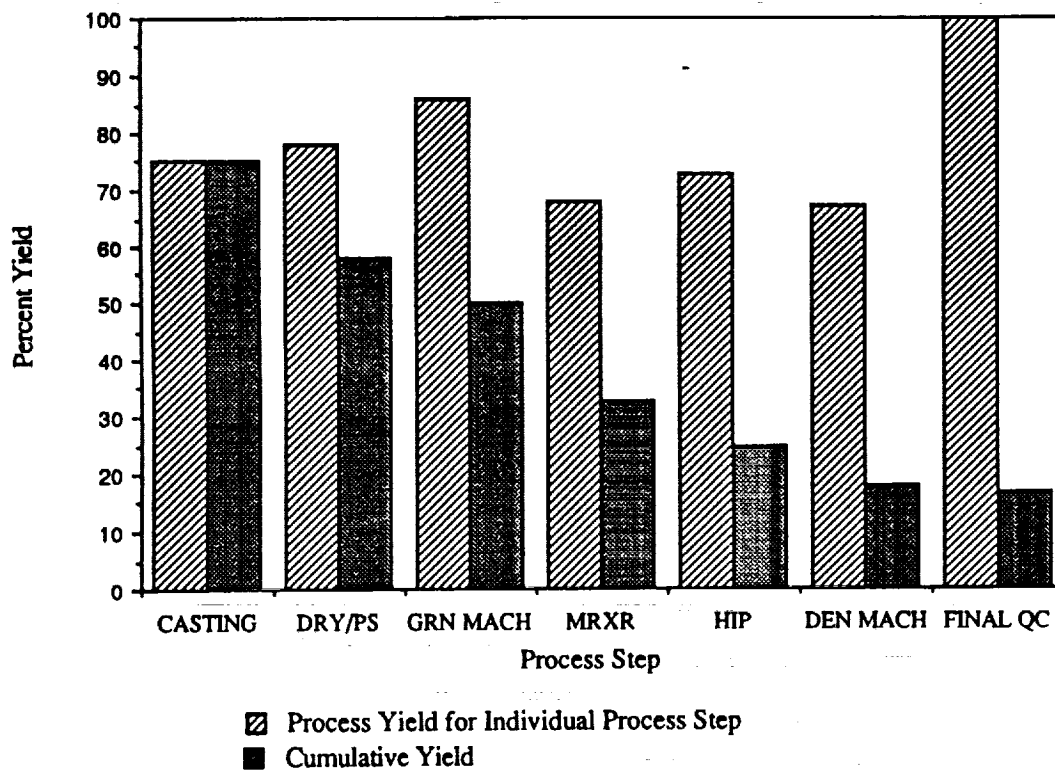
Figure 65. AGT101 Rotor Deliverable Set No. 3 Process Yields.

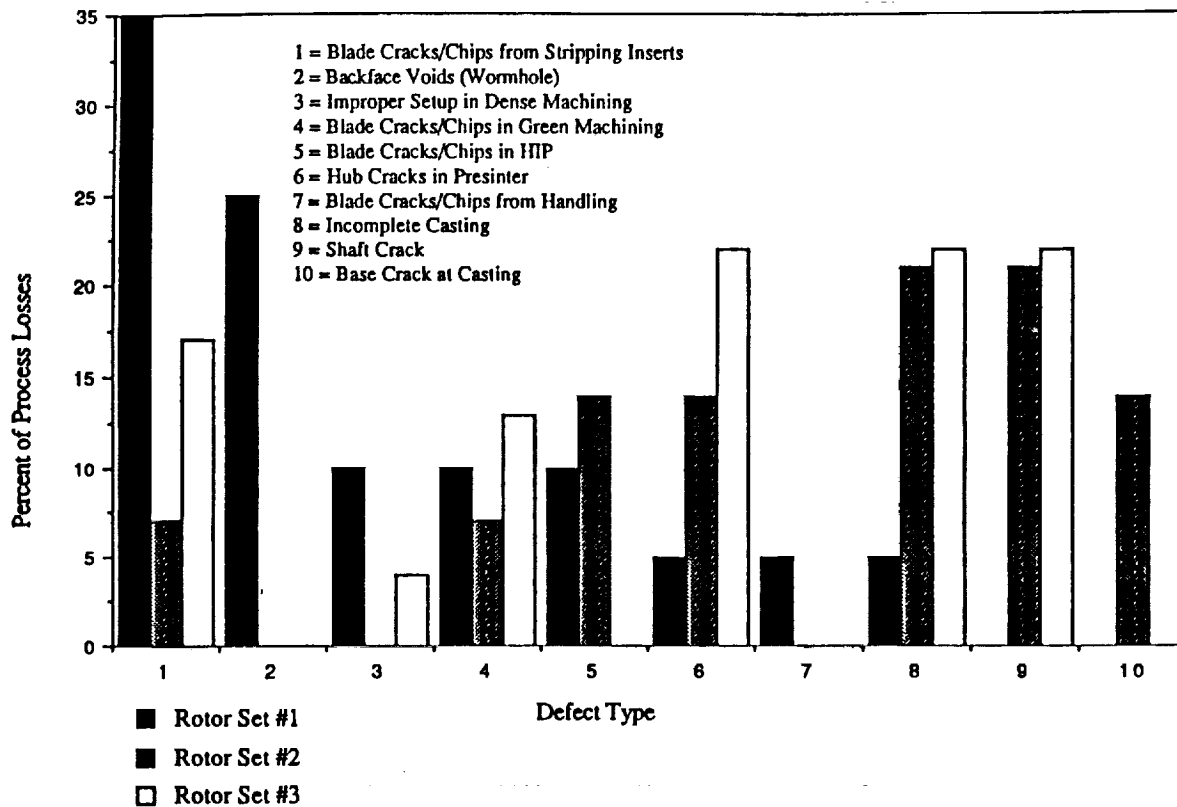
Figure 66. AGT101 Rotor Process Losses By Defect Type.

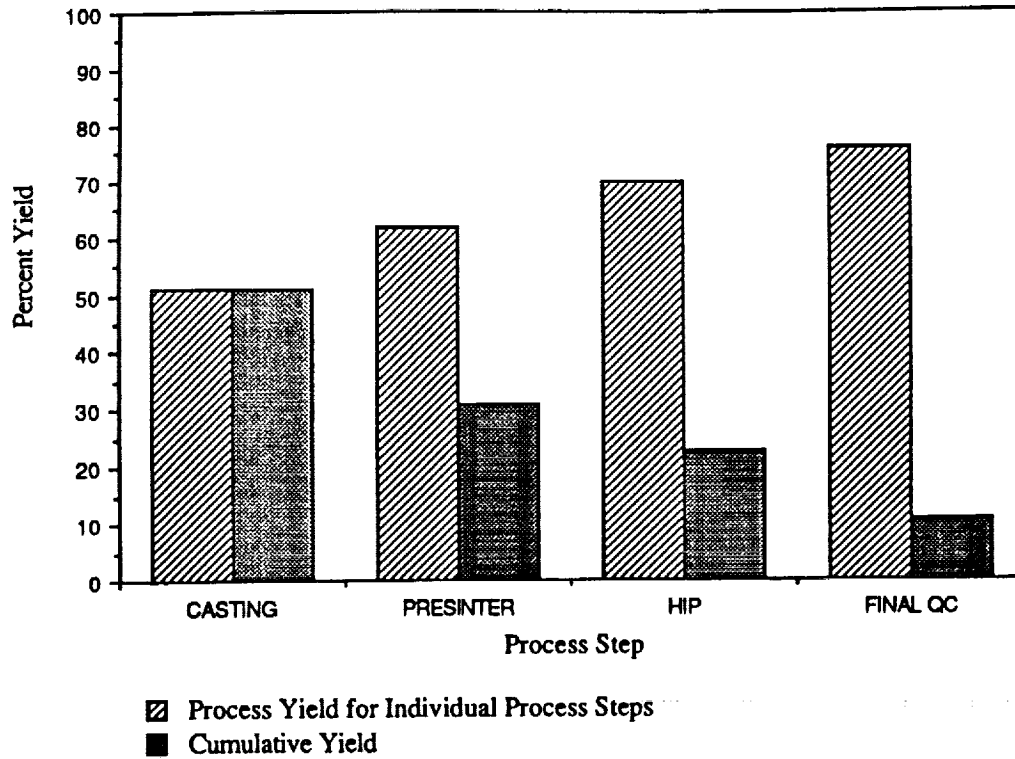
**Figure 68. AGT101 Stator Deliverable Set No. 1 Process Yields.**

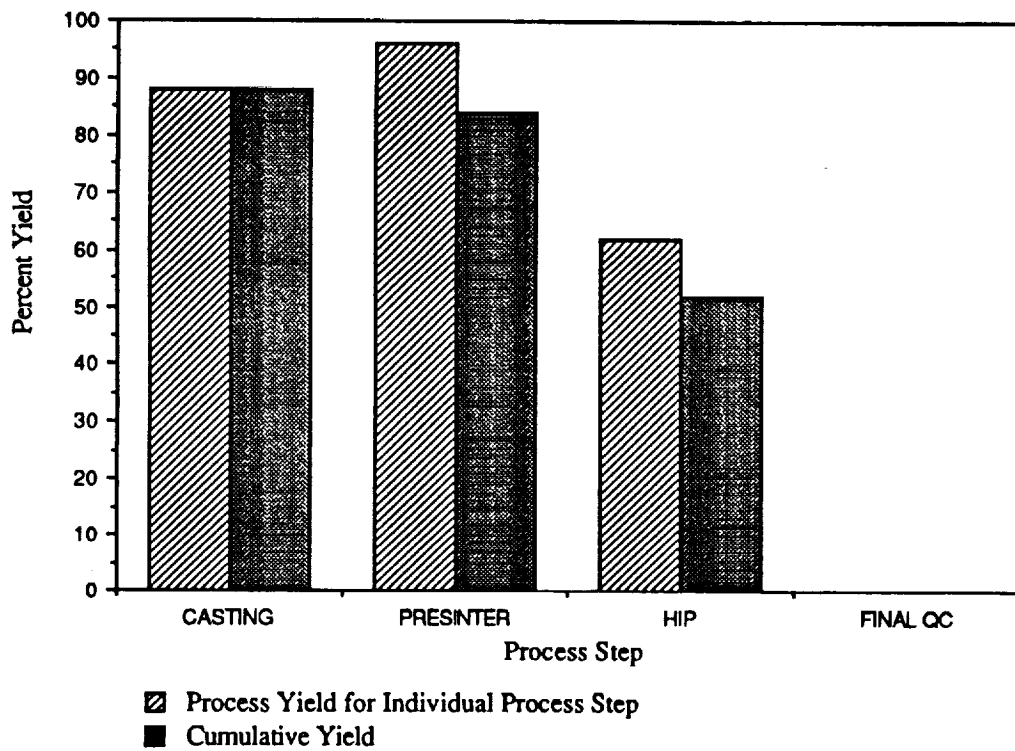
Figure 71. AGT101 Stator Deliverable Set No. 4 Process Yields.

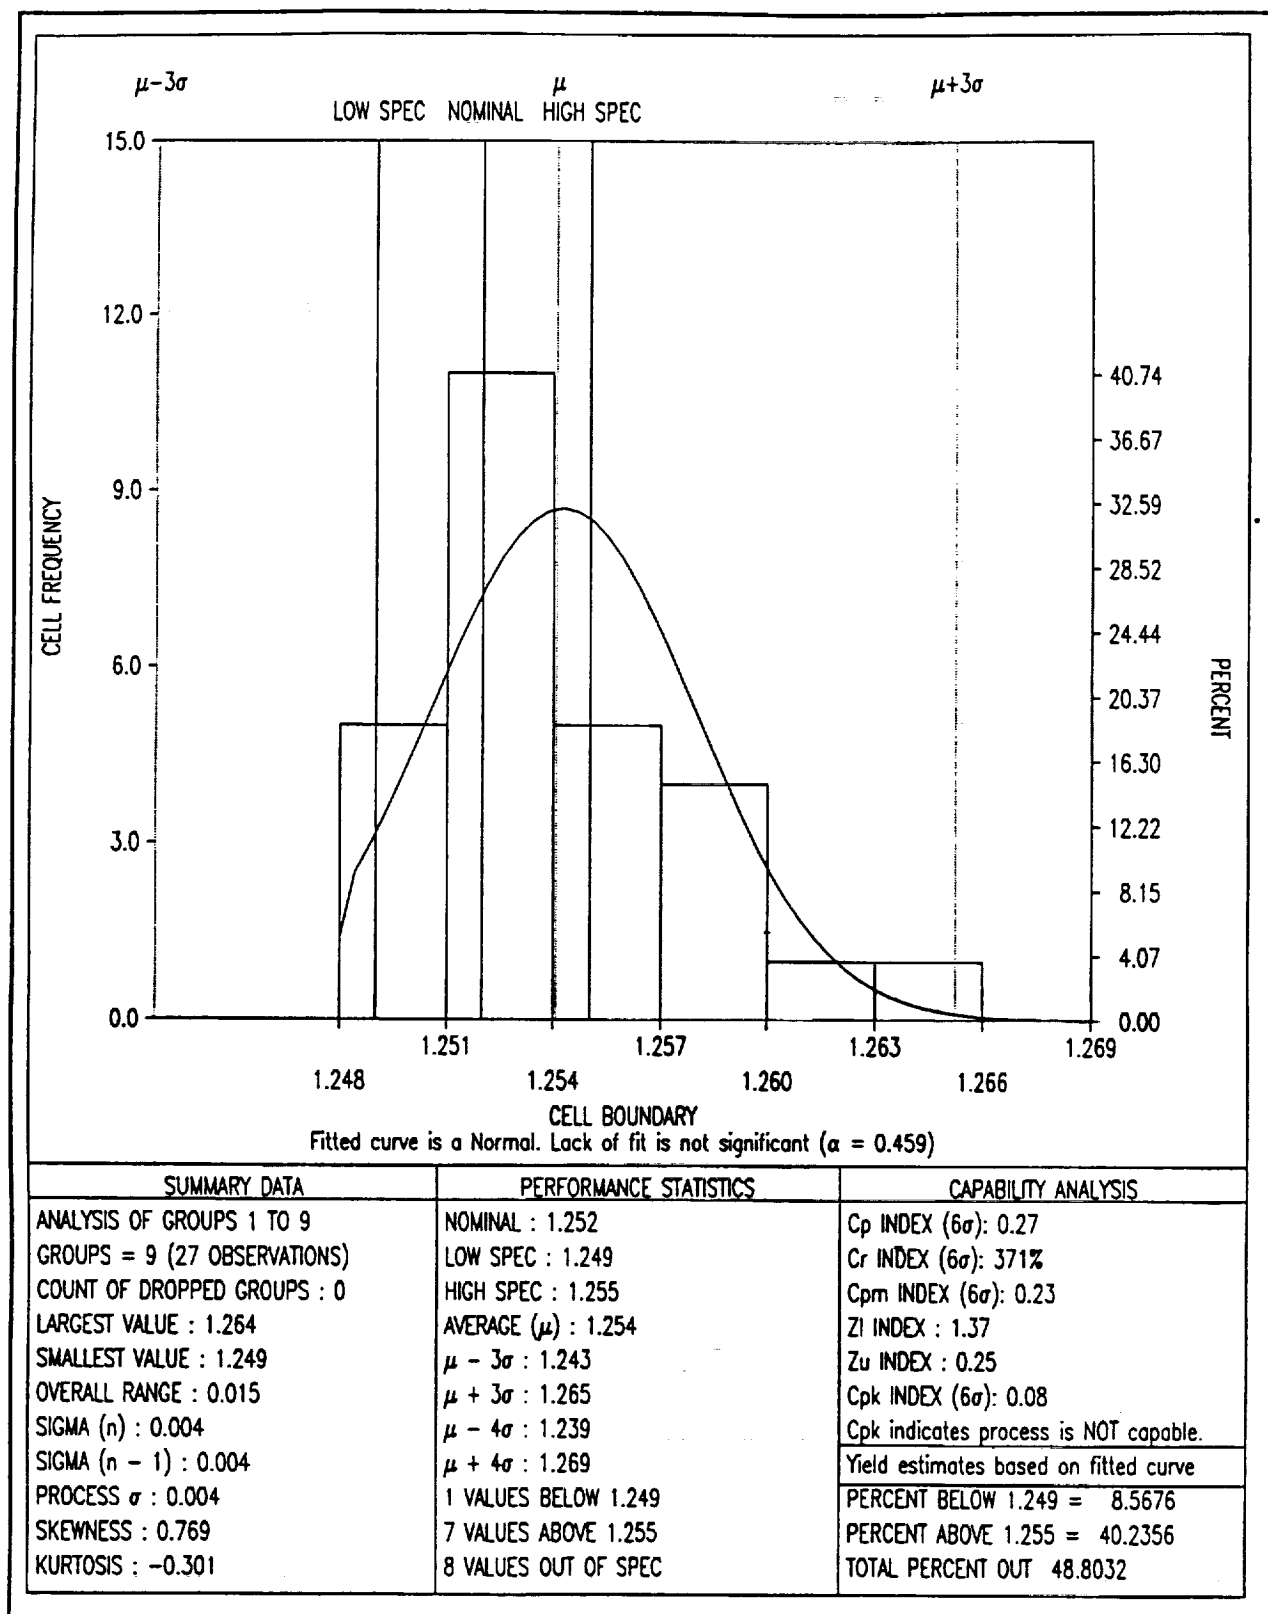
Figure 72. AGT101 Stator Deliverable Set No. 3 - Histogram Of Z-Section CMM Data.

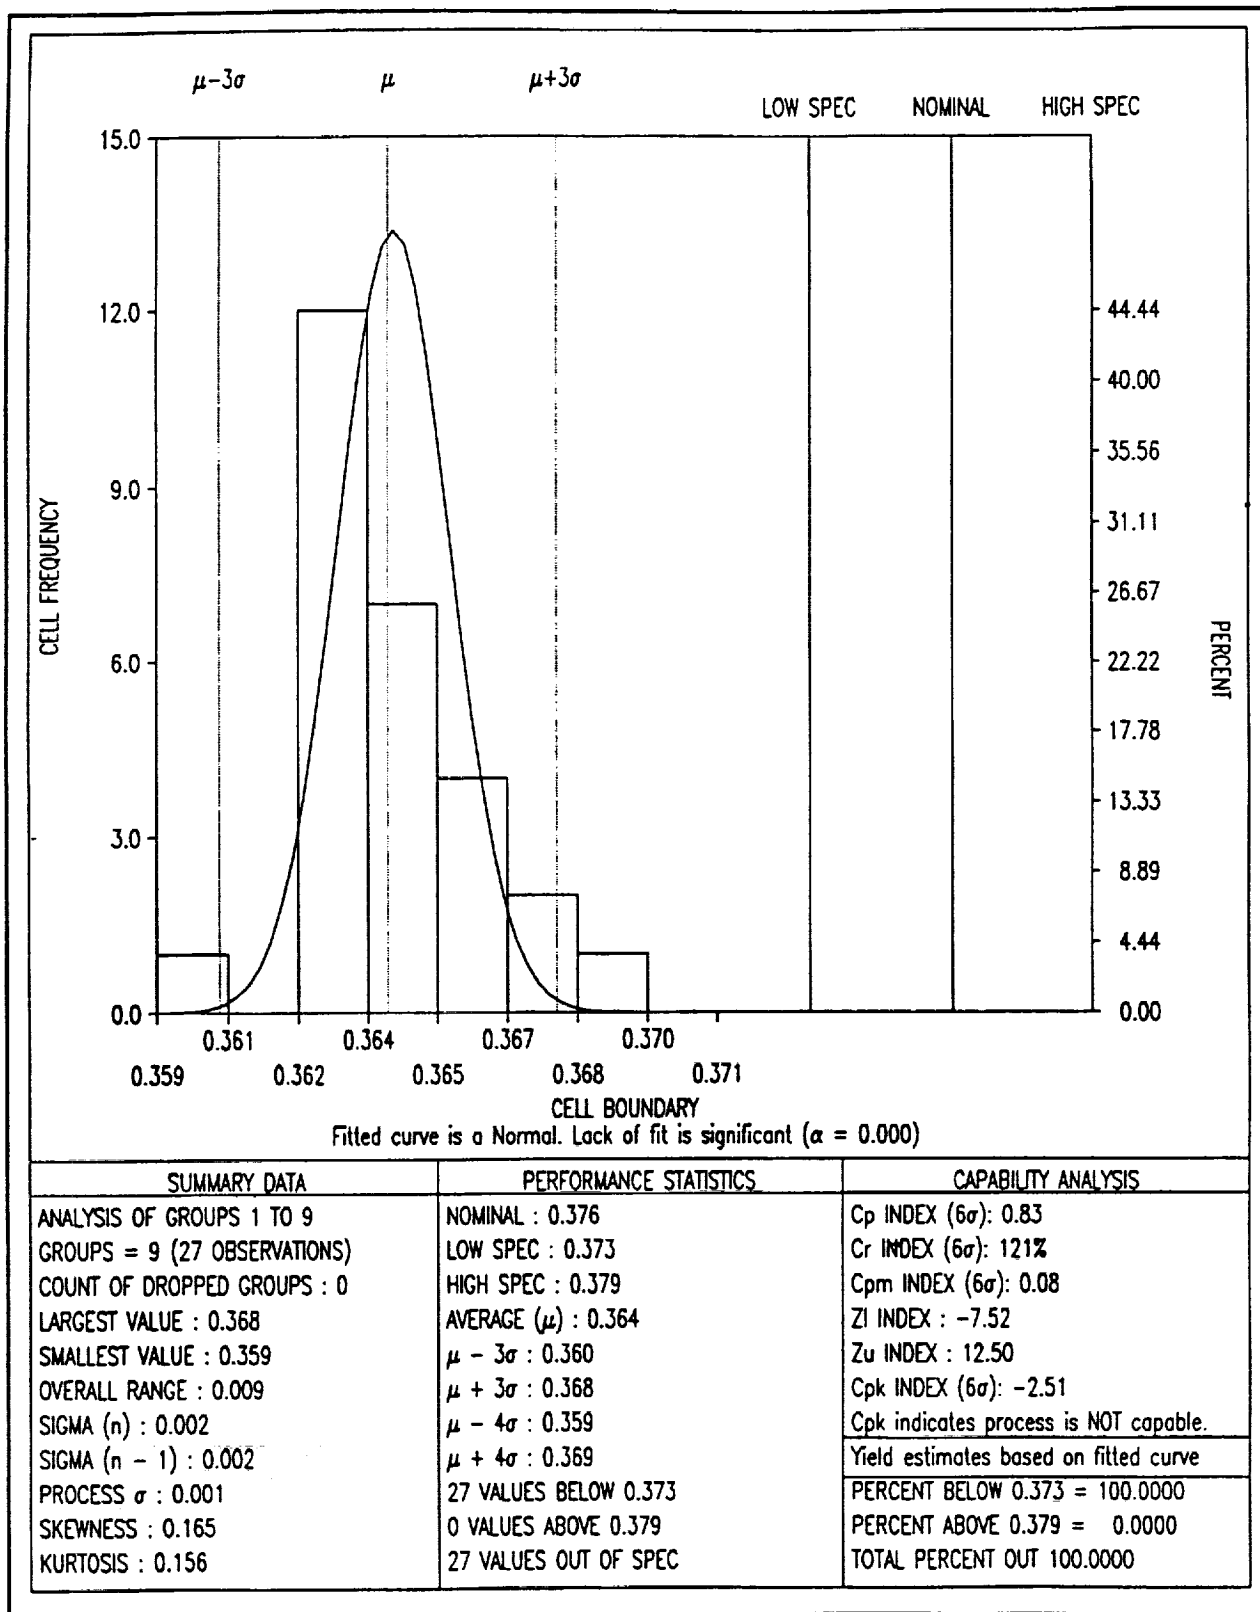
Figure 73. AGT101 Stator Deliverable Set No. 3 - Histogram Of L-Section CMM Data.
